# **FLOOD PLAIN MANAGEMENT**

**A Study Of South Fork  
Shenandoah Tributaries**

**Rockingham County, Virginia**

**CUB RUN – BIG RUN**

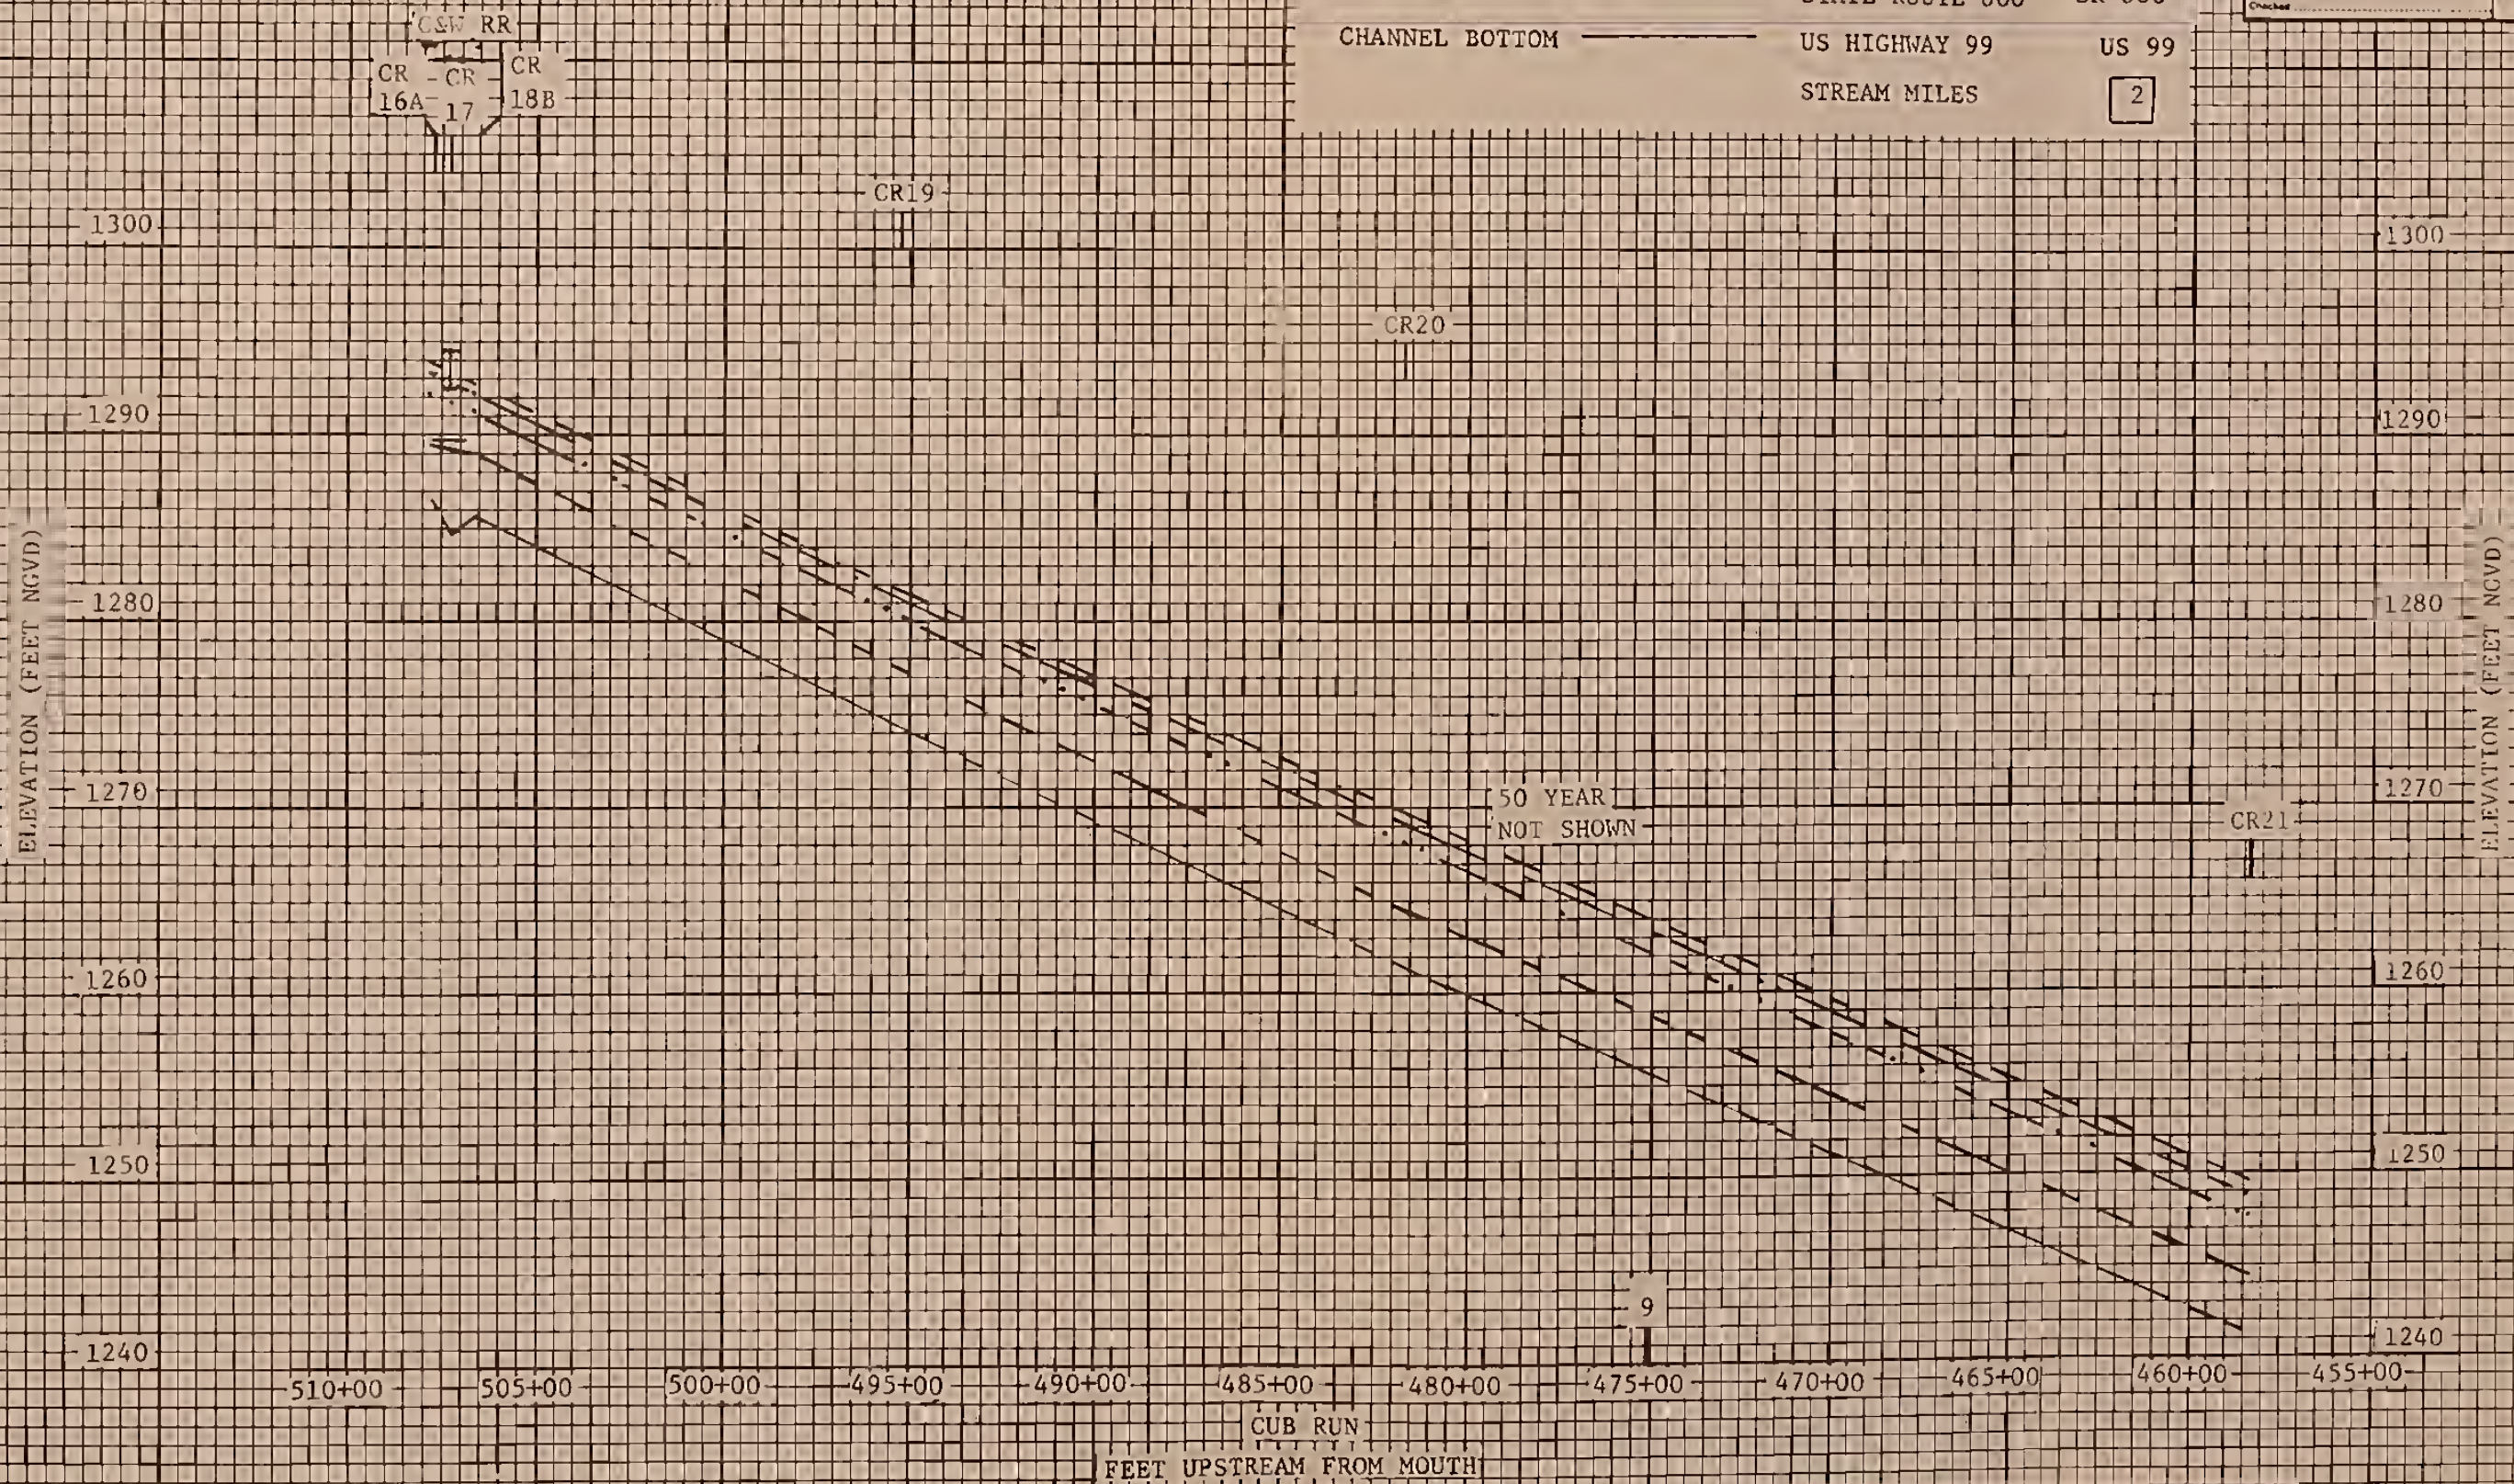
PLATE 4 of 11  
CUB RUN - See  
Photomap CR2

FLOOD PROFILES  
S FK SHENANDOAH RIVER TRIBS  
ROCKINGHAM COUNTY, VIRGINIA  
U. S. DEPARTMENT OF AGRICULTURE  
SOIL CONSERVATION SERVICE

Flood profile plates provide elevations of the 10, 50, 100 and 500-year floods at any location along the length of the streams. The elevations and discharges of the 10, 25, 50, 100 and 500-year flood at each surveyed cross section are given in Table CR-1. Sample cross sections illustrated how the flood area boundaries were located. Table CR-2 provides the description and elevation of benchmarks which are located on the photomaps.

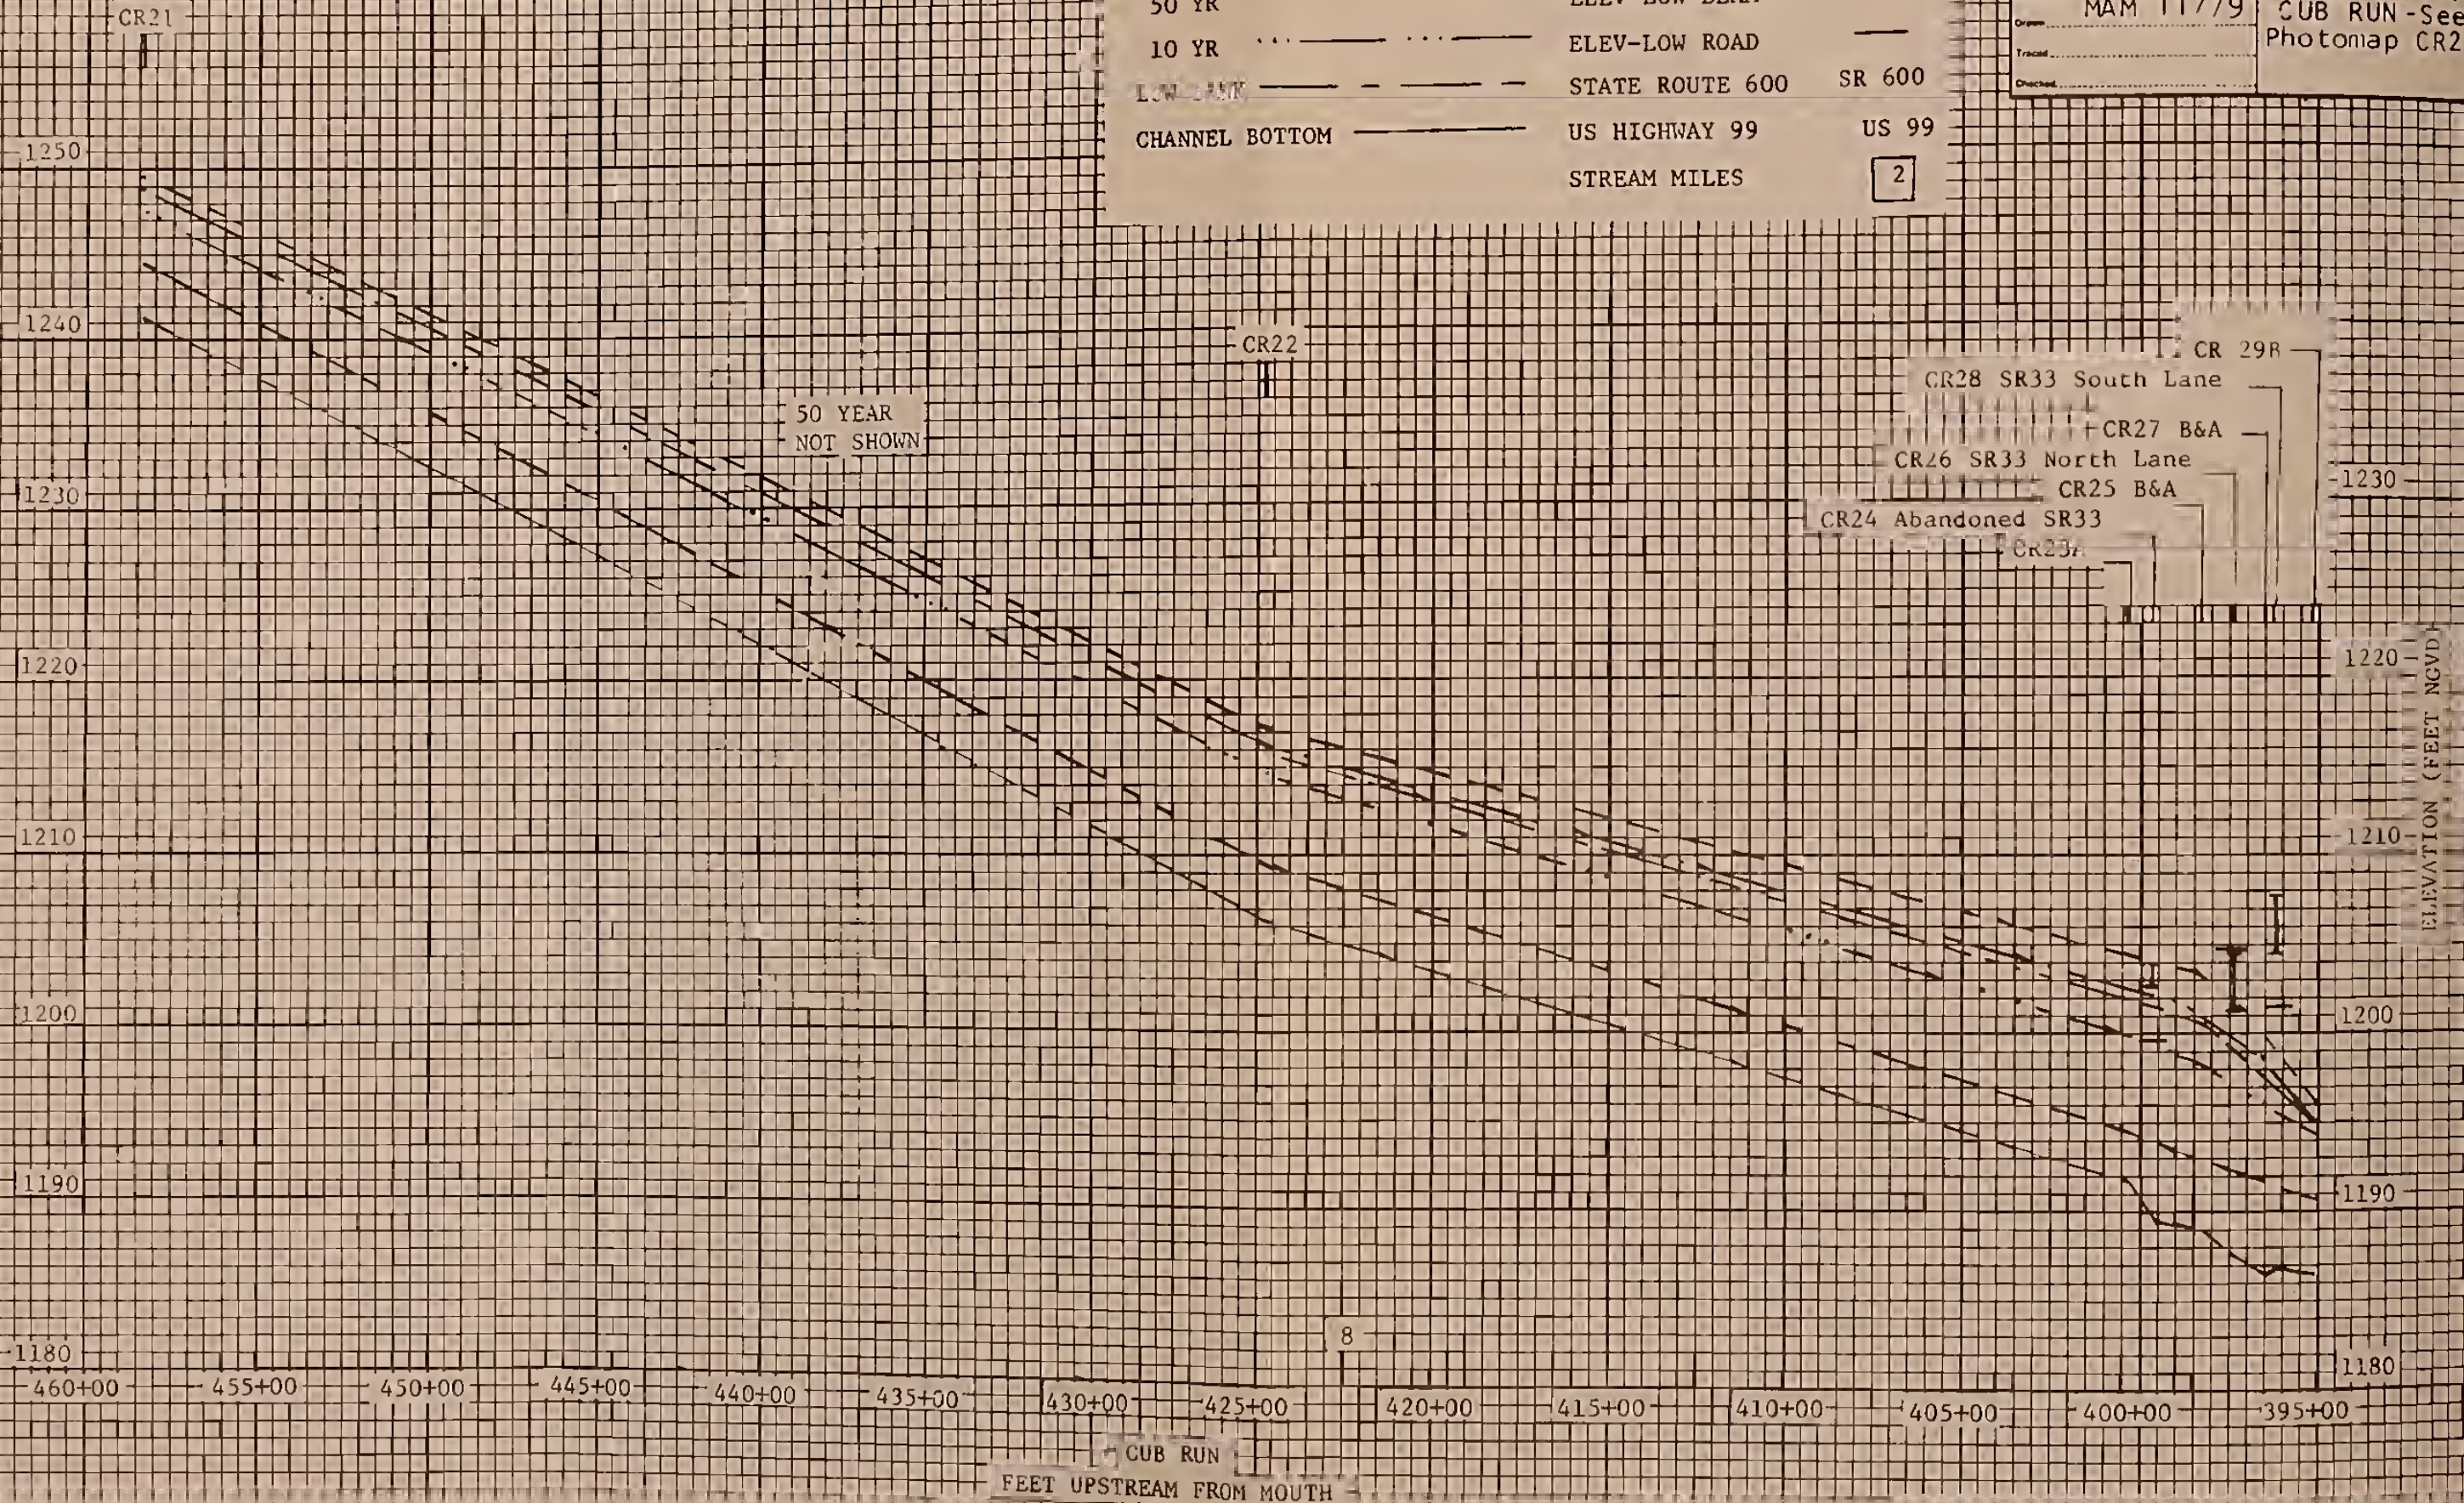
FLOOD PROFILES	
S FK SHENANDOAH RIVER TRIBS	
ROCKINGHAM COUNTY, VIRGINIA	
U. S. DEPARTMENT OF AGRICULTURE SOIL CONSERVATION SERVICE	
Designed: MAM 11779	Date: PLATE 5 of 11
Drawn: _____	CUB RUN-See
Traced: _____	Photomaps
Checked: _____	CR2 & CR3

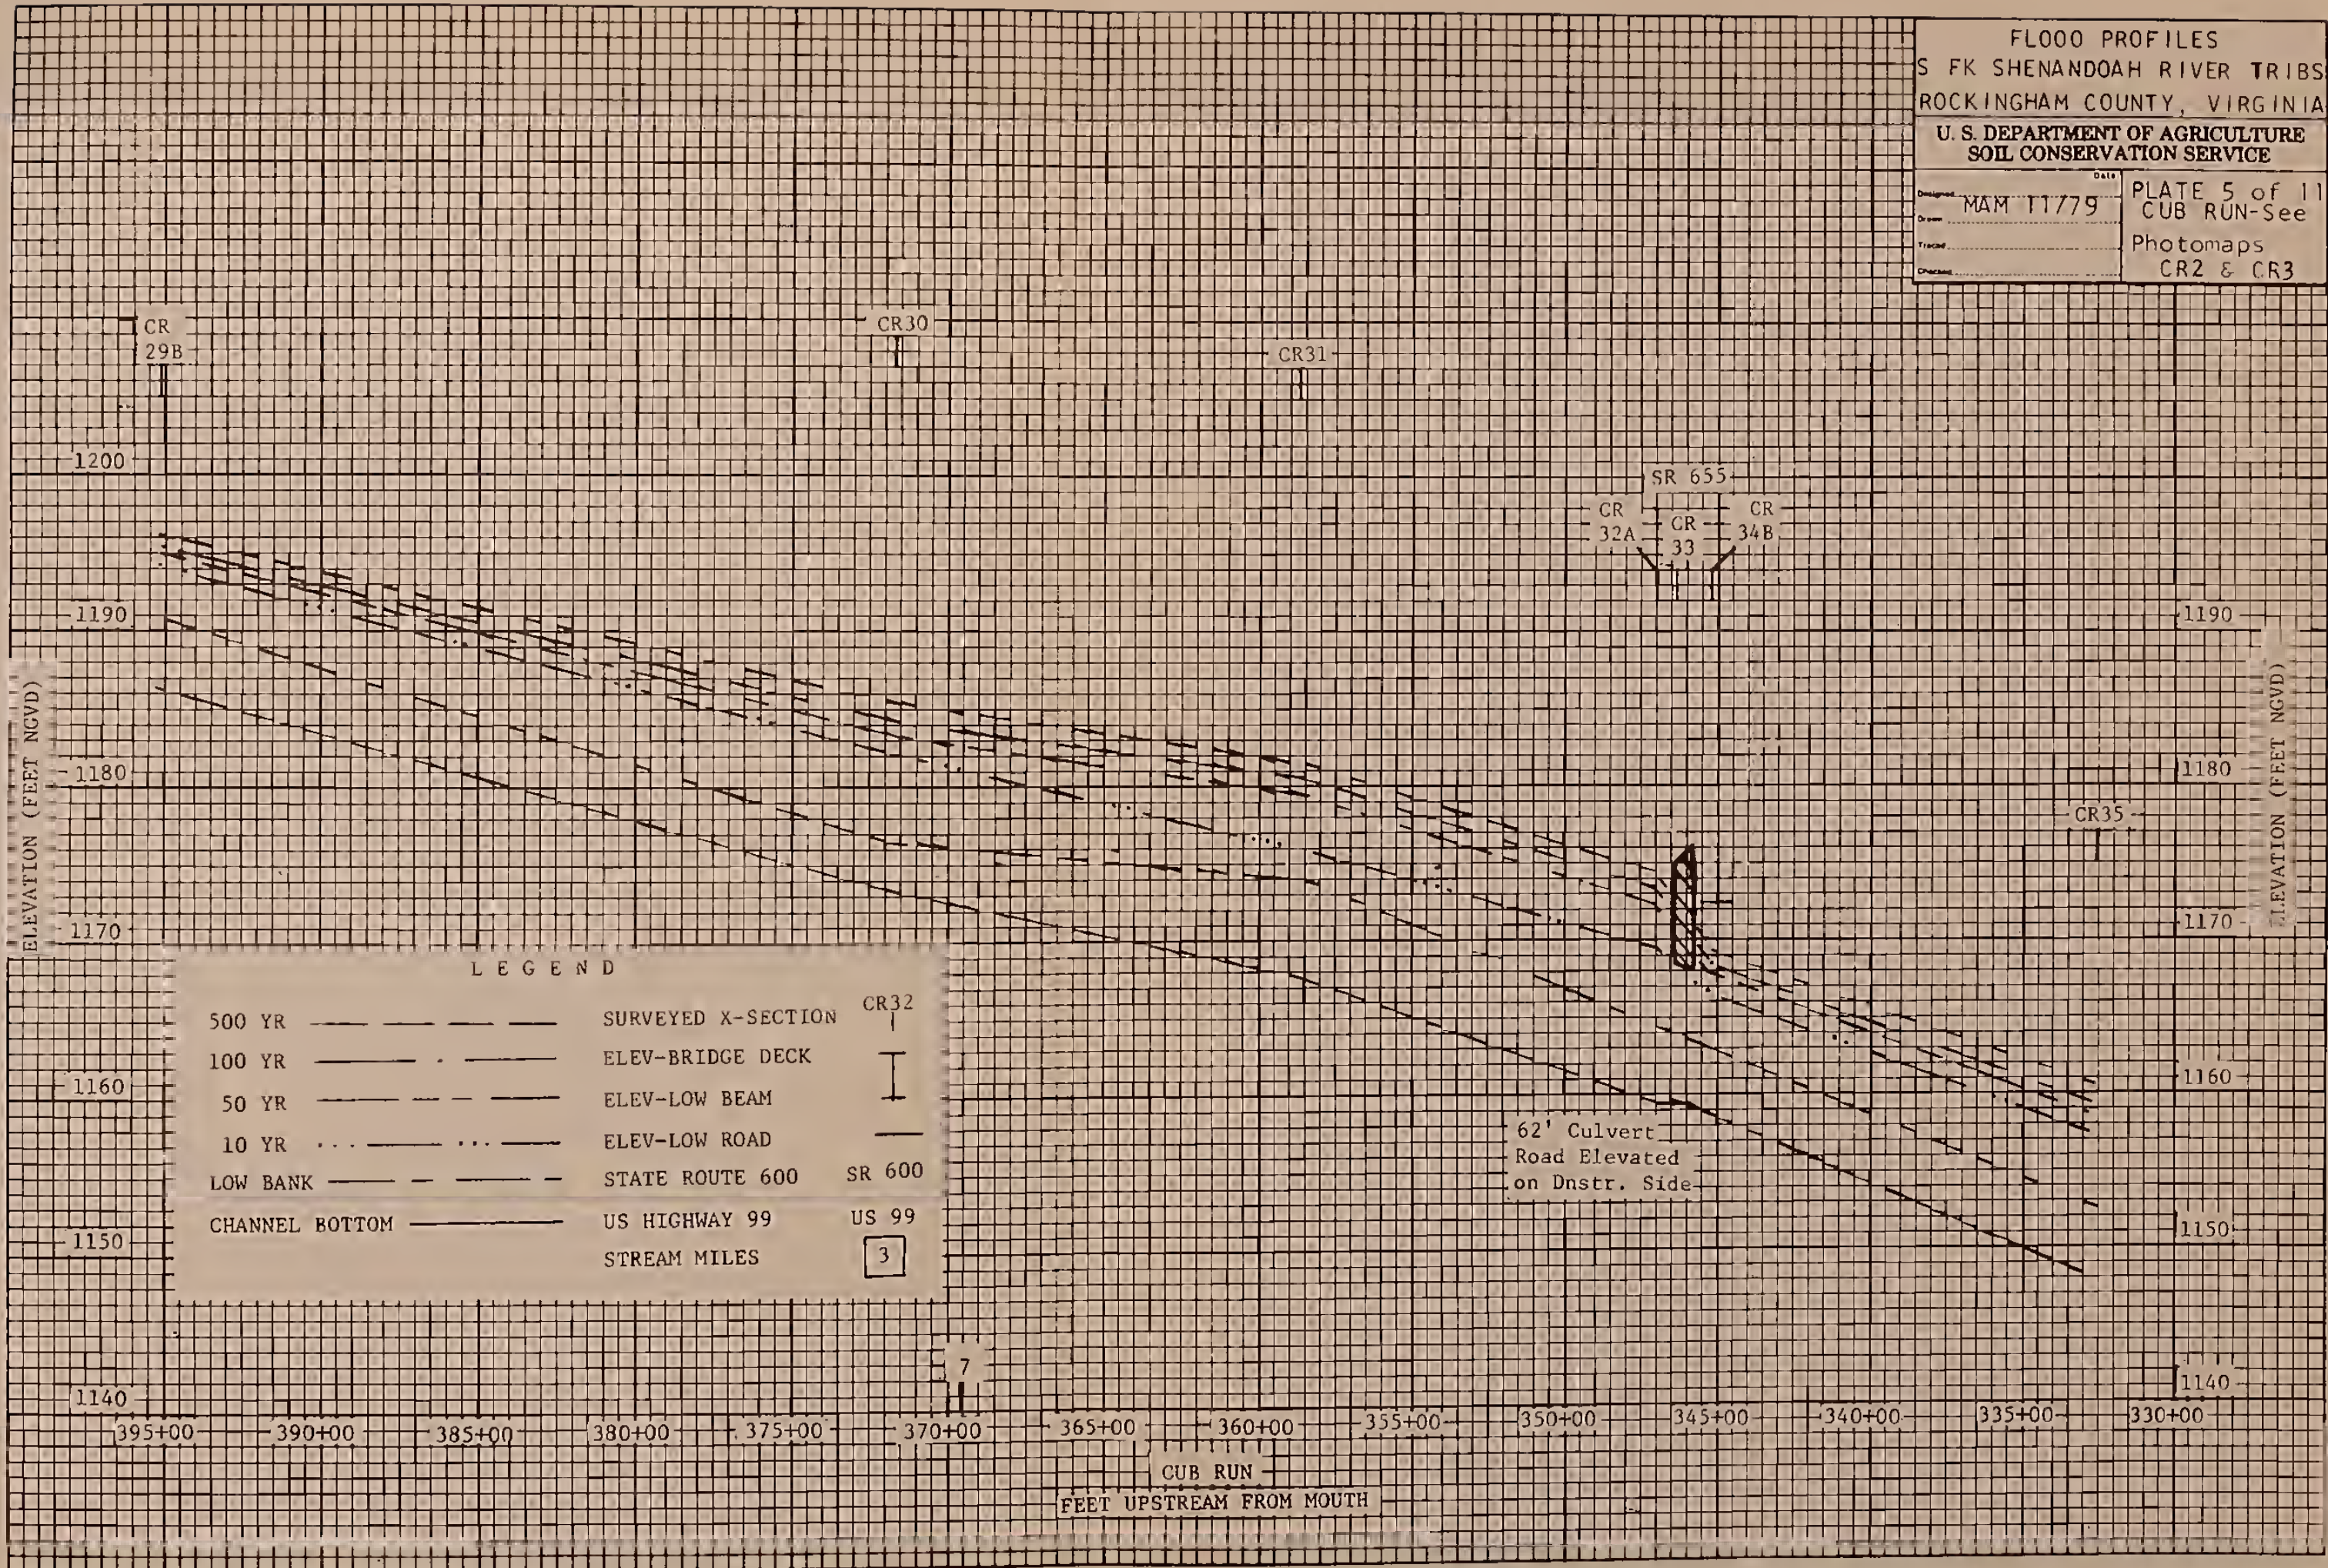
FLOOD PROFILES	
S FK SHENANDOAH RIVER TRIBS ROCKINGHAM COUNTY, VIRGINIA	
U. S. DEPARTMENT OF AGRICULTURE SOIL CONSERVATION SERVICE	
Designed	Date
Drawn	PLATE 6 of 11
Traced	CUB RUN-See
Checked	Photomap CR3

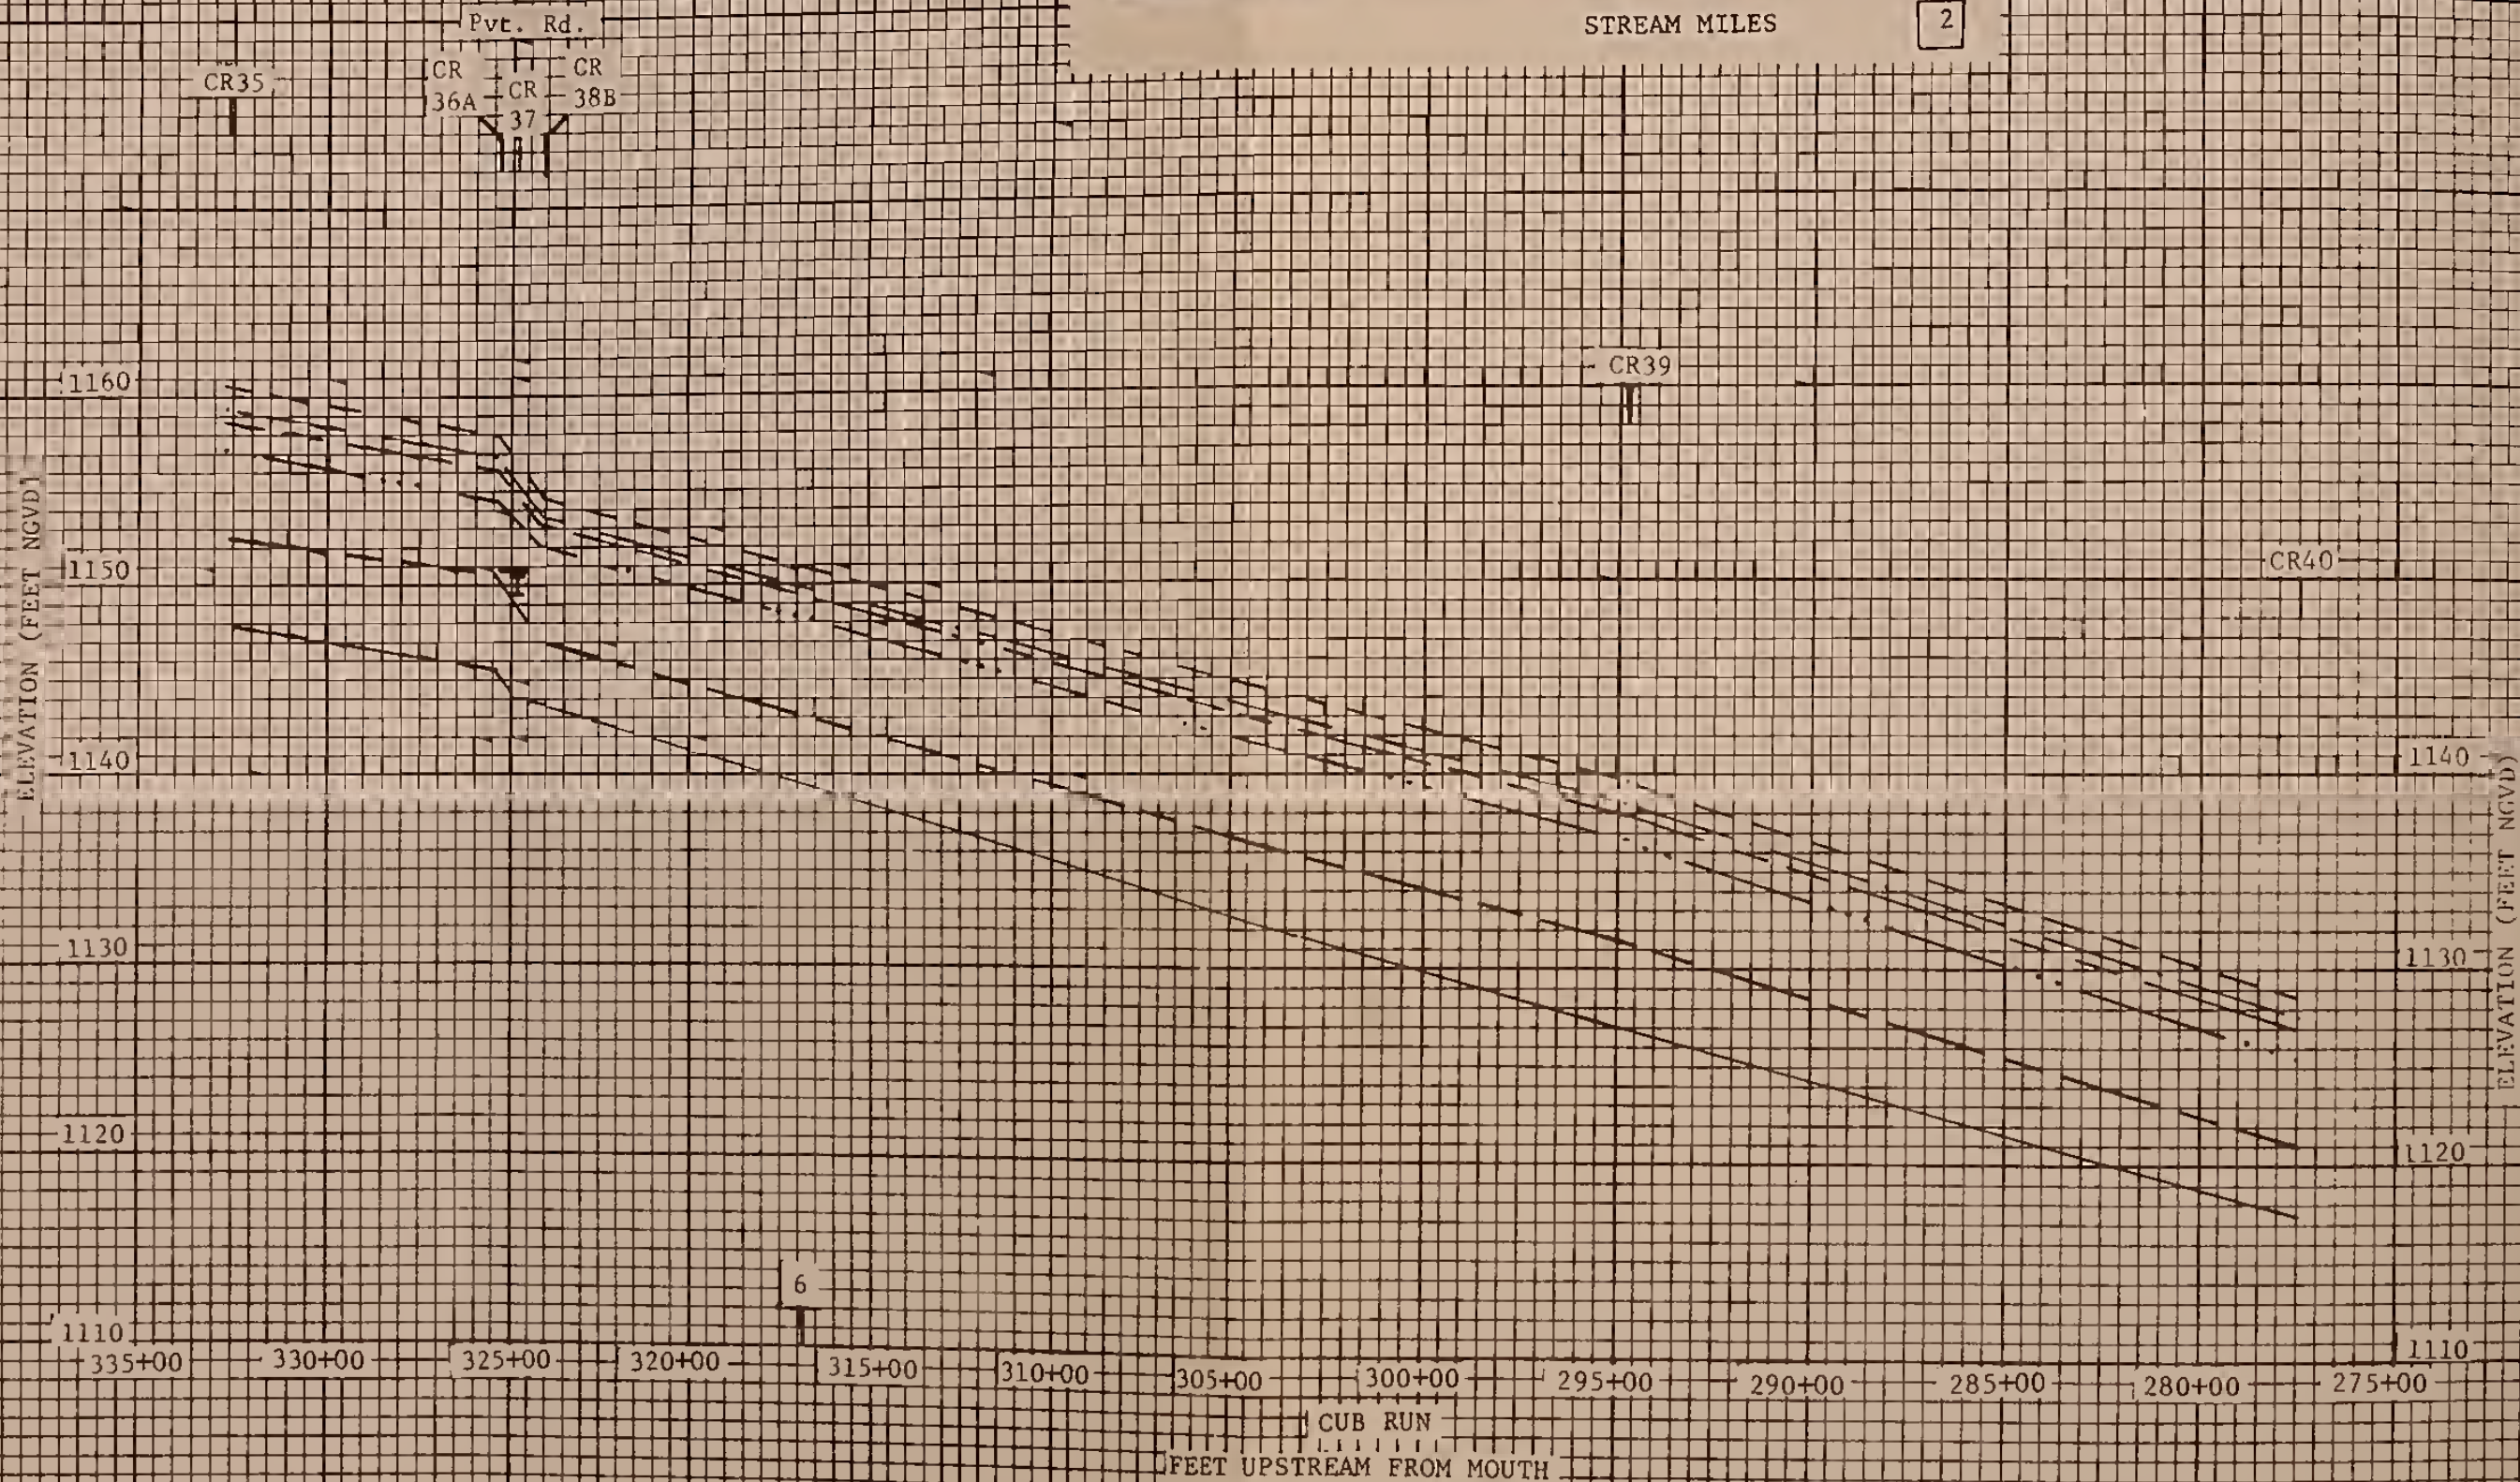
FLOOD PROFILES	
S FK SHENANDOAH RIVER TRIBS	
ROCKINGHAM COUNTY, VIRGINIA	
U. S. DEPARTMENT OF AGRICULTURE SOIL CONSERVATION SERVICE	
Designed	DATE
Drawn	PLATE 7 of 11
Traced	CUB RUN-See
Checked	Photomaps
	CR3 & CR4

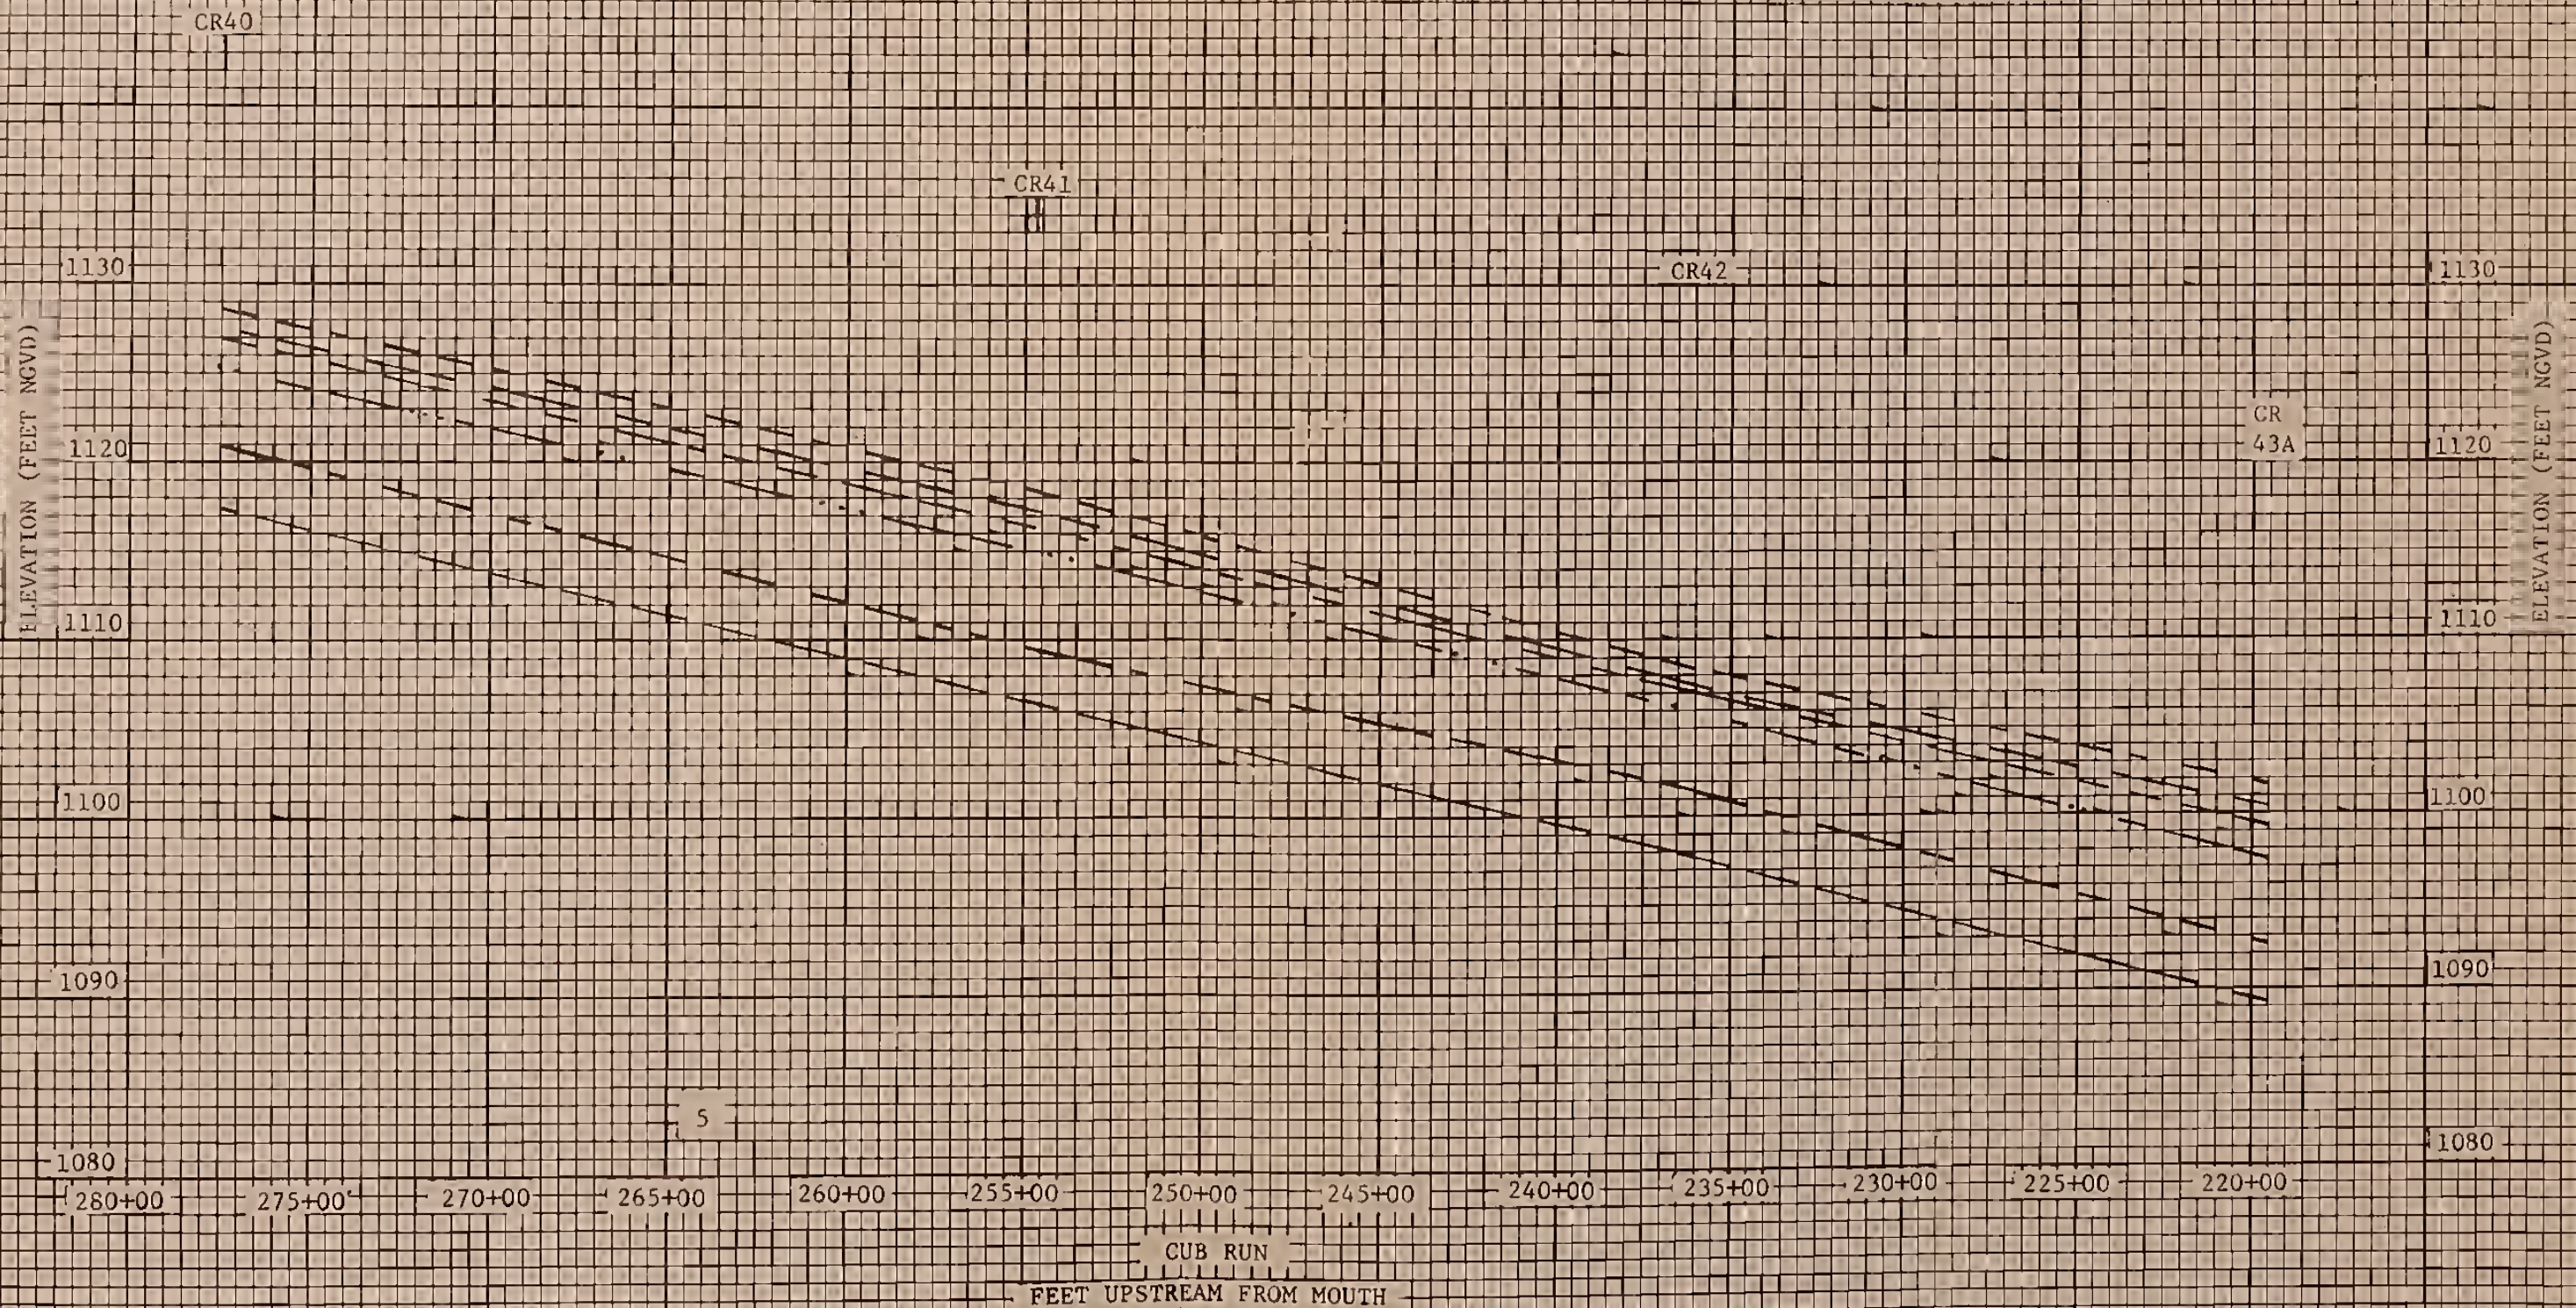
PLATE 8 of 11  
CUB RUN - See  
Photomap CR4

FLOOD PROFILES  
S FK SHENANDOAH RIVER TRIBS  
ROCKINGHAM COUNTY, VIRGINIA

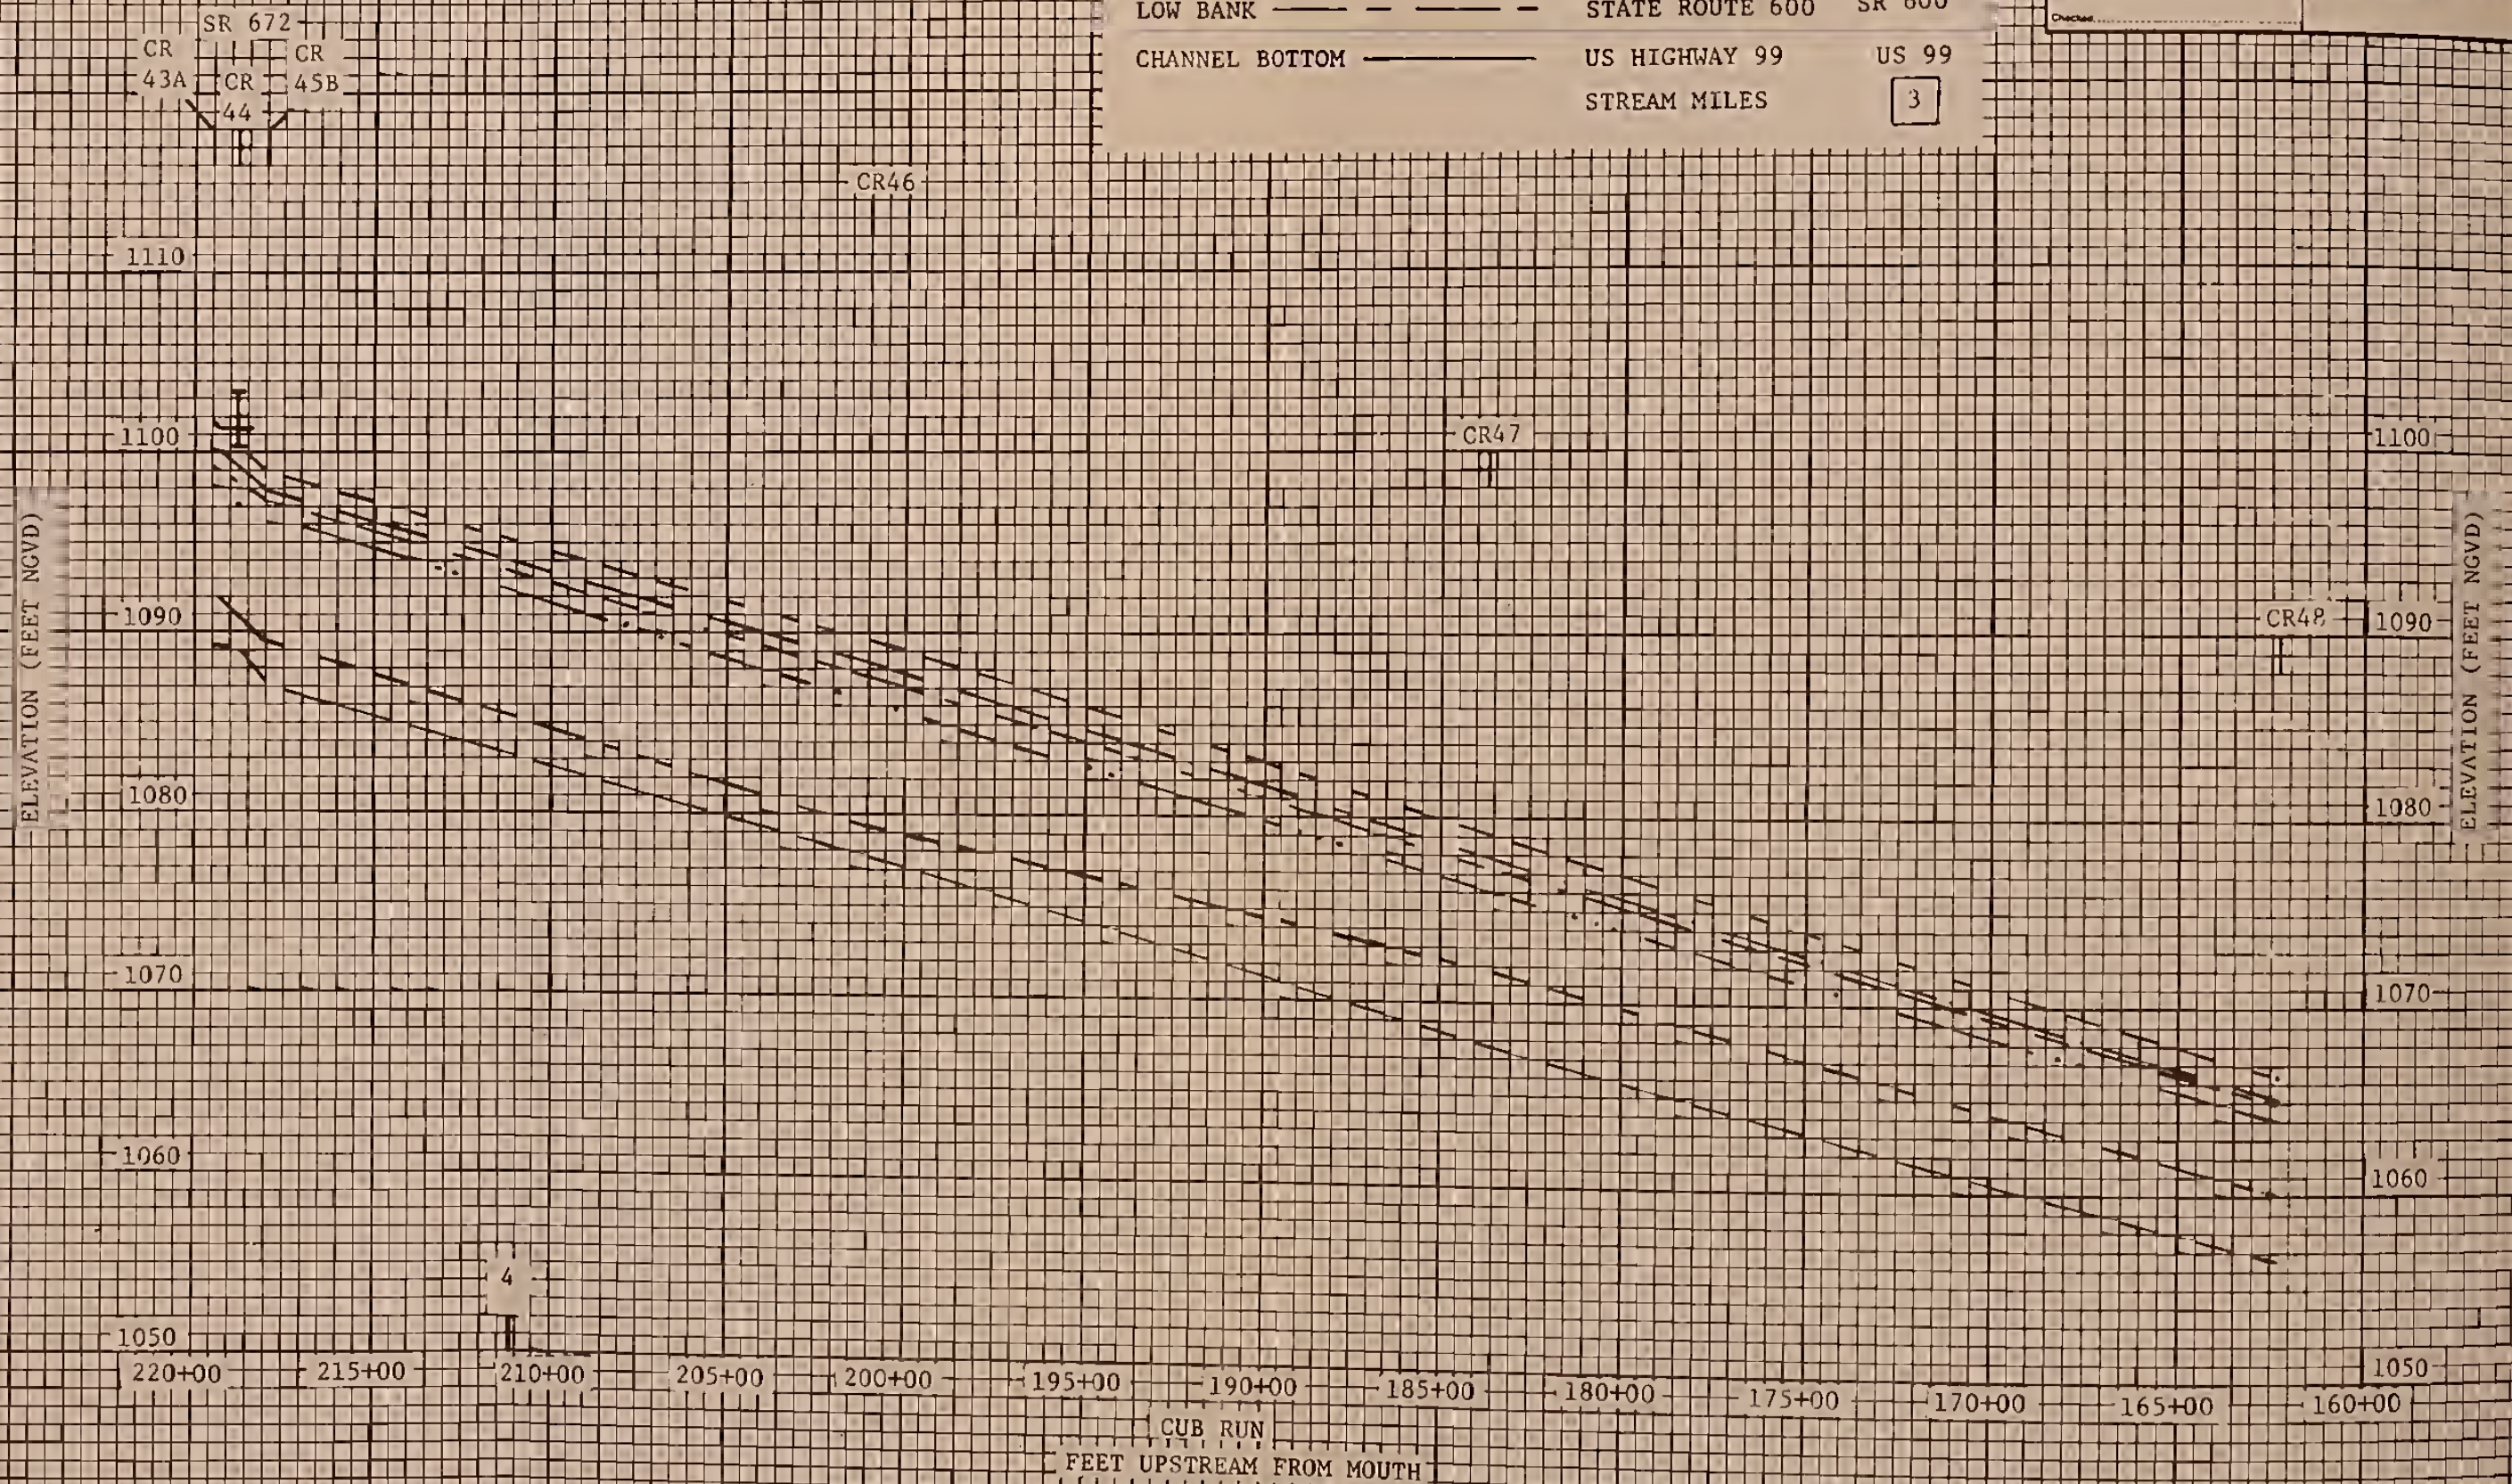
FLOOD PROFILES  
S FK SHENANDOAH RIVER TRIBS  
ROCKINGHAM COUNTY, VIRGINIA

Date: 11/79  
Designed: MAM  
Drawn: CUB RUN - See  
Traced: Photomap CR4  
Checked:
